SILICON NITRIDE JOINING

Annual Report

March 1983

By: S. M. Johnson and D. J. Rowcliffe

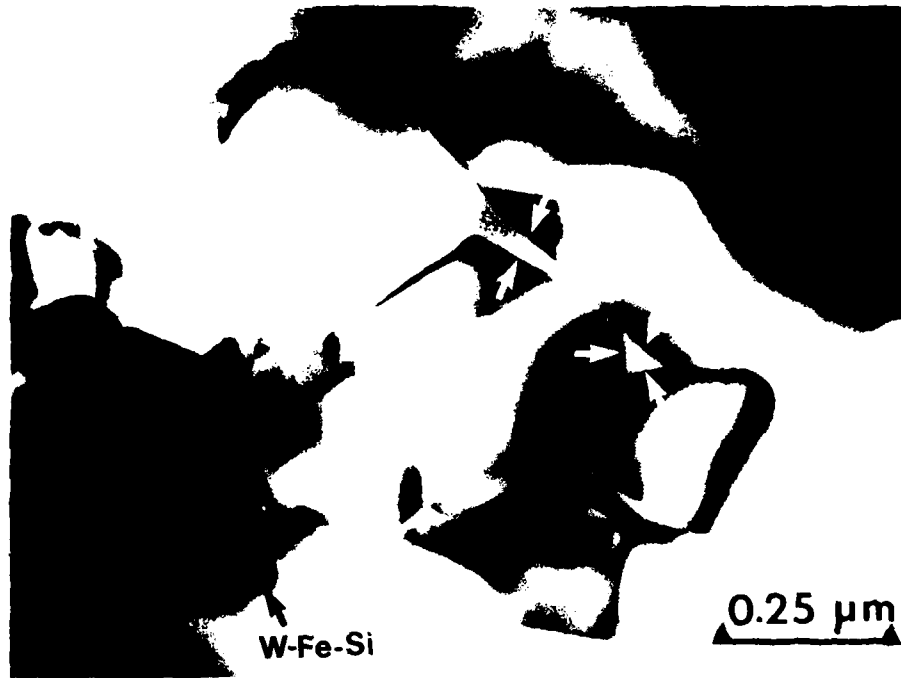
JP-2527-16

Normalized Composition

Si	Mg	Al	Ca
1.0	0.42	0.02	0.001

FIGURE 7 MICROSTRUCTURE OF AS-RECEIVED Si_3N_4 AND EDAX ANALYSIS OF GLASS POCKET (ARROWED)

The microstructure of the as-received Si_3N_4 is shown in Figure 7, with an EDAX analysis of one of the large ($\sim 1000 \text{ \AA}$) glass pockets. The weight ratio of the Si:Mg:Al:Ca in the glass is 1.0:0.42:0.02:0.001. The Si content in the glass appears high, but this is probably a result of the size of the electron beam being larger than the glass pocket. For comparison, a typical EDAX analysis of the glass in a joint gives a Si:Mg:Al ratio of 1:0.78:0.11, whereas the calculated ratio in HN-9M glass is 1:0.81:0.12.

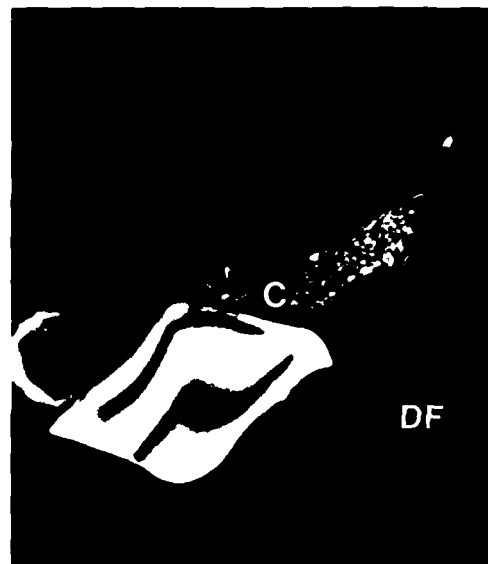
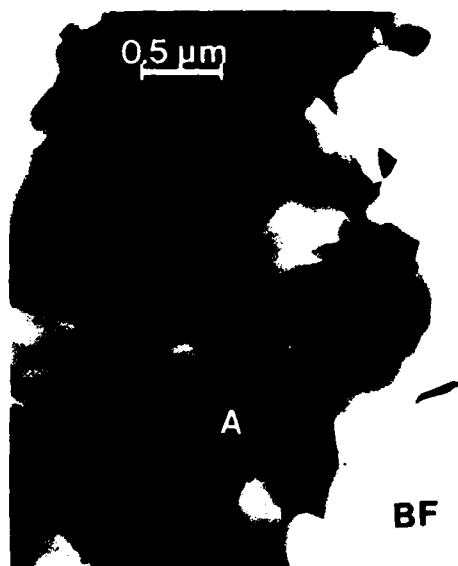
JP-2527-19

BF—Bright Field
DF—Dark Field
A—Amorphous
C—Crystalline

FIGURE 9 BRIGHT AND DARK FIELD IMAGES OF AMORPHOUS (A) AND CRYSTALLINE (C) REGIONS NEAR THE JOINT

Si_3N_4 grains are dissolving in large glass pocket in (a)

Crystallization of some glass pockets in samples joined with HN-9M-13 wt% Sc glass was observed [Figure 8(c)]. Amorphous (A) and crystallized (C) pockets near the joint region are shown in Figure 9. EDAX analyses of crystallized regions both near and far from the joint indicate that they

Silicon nitride crystals dissolving in the glass can be seen in the dark field image, Figure 9(a). Dissolution of Si_3N_4 is followed by precipitation of acicular $\text{Si}_2\text{N}_2\text{O}$ crystals. Figure 10 shows a $\text{Si}_2\text{N}_2\text{O}$ crystal growing into the glass from an area containing a dissolving Si_3N_4 grain. The acicular shape is characteristic of $\text{Si}_2\text{N}_2\text{O}$ grown under these conditions. The identification is confirmed by the selected area electron diffraction pattern shown in Figure 10. $\text{Si}_2\text{N}_2\text{O}$ crystals of up to 15 μm were observed using both TEM and SEM.
